Field Report for Airborne Data Collected In Support of US EPA Region VI International Terminal Corporation Fire 18 March 2019

Figure 1: International Terminal Corporation, Deer Park, TX

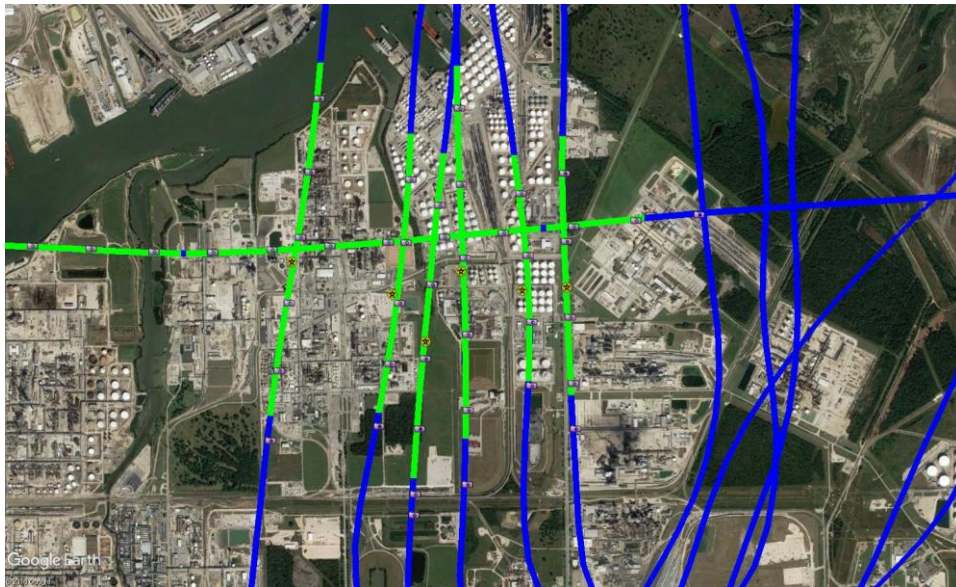
Figure 2: Data collection passes, International Terminal Corporation Fire, Deer Park, TX. The blue lines represent the ASPECT flight path, green lines represent when the Infrared Line Scanner was actively collecting data, and the camera icons represent when a photo was taken.

The order to launch the aircraft was given at 1000 local on 18 March 2019 and the aircraft was airborne at 1055. The initial data collection run over the site was at 1252 (local) The aircraft made a total of seven data collection passes; flight information is summarized in Appendix A and Figure 2.

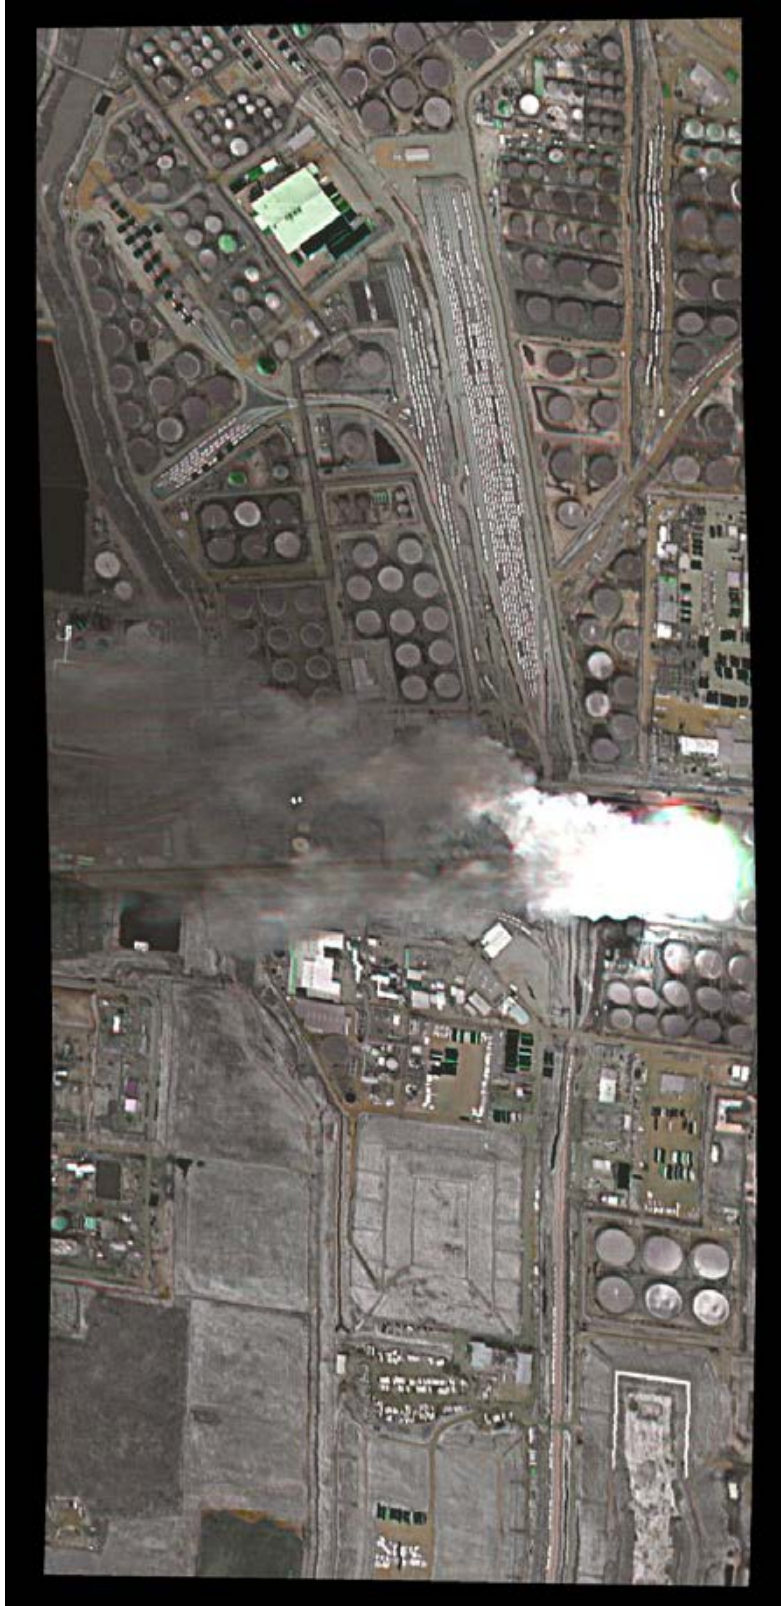
A total of 1 test and 7 data passes were made in the proximity of the site and an infrared line scanner images were generated for each pass. Figure 3 shows a typical 3-band infrared image obtained from data collected for Run 5. The image clearly shows that the fire is very intensive and is not only generating a hot target (as white) but is also producing an extended plume of hot air as the plume moves to the west. An examination of the area to the west shows almost total obscuration most likely due to particulate loading of the plume and to a certain extent thermal masking of the surface signal.

Figure 3: – 3 band IR image, Run 5, International Terminal Corporation Fire, Flt 2

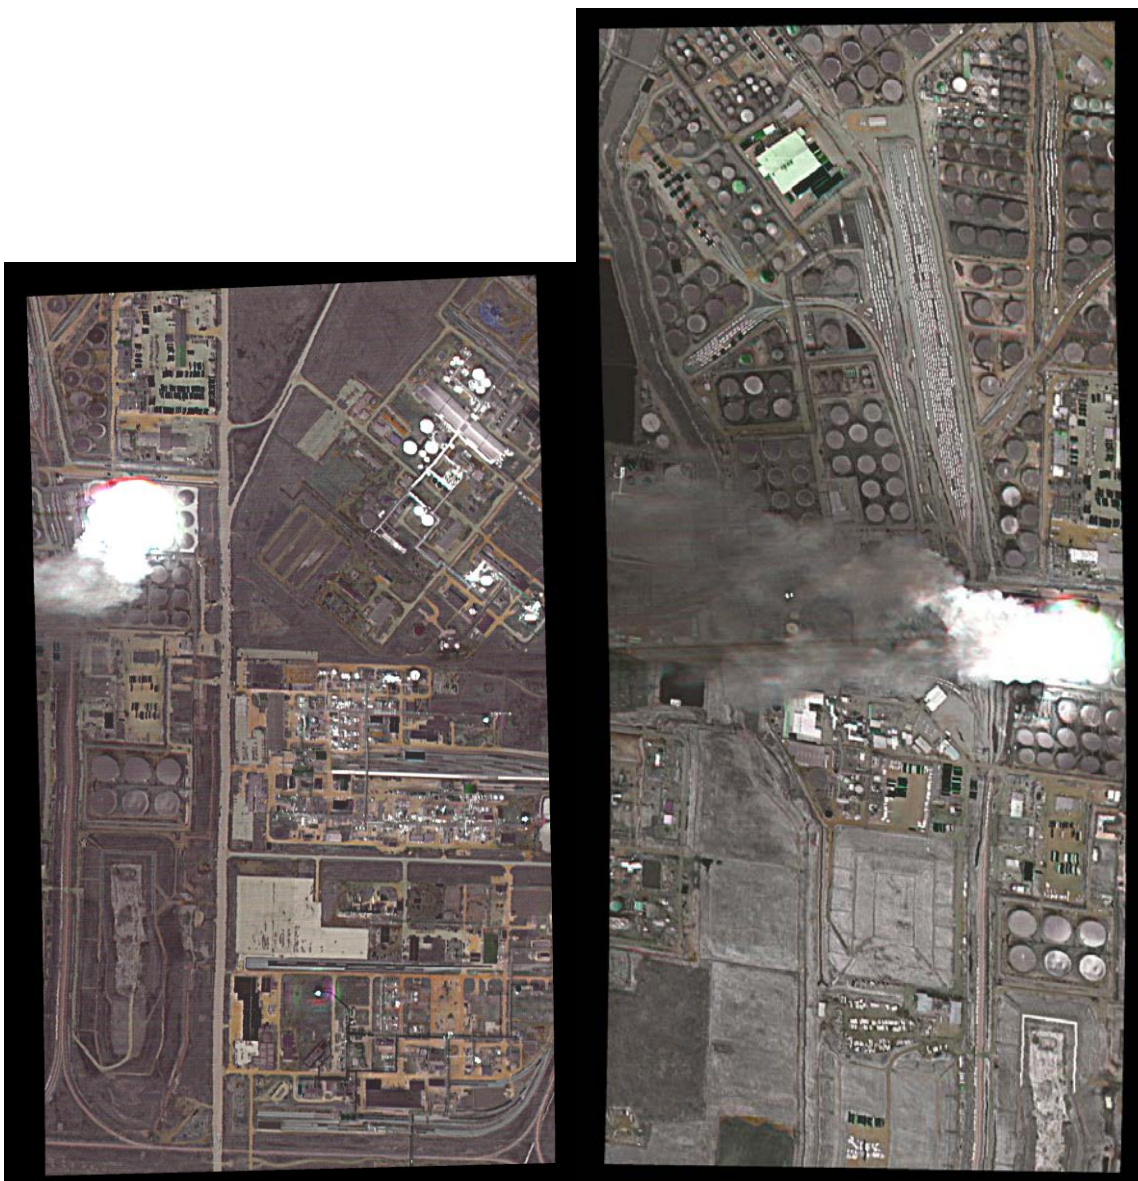
Figure 4 shows a comparison of IR data collected on 17 March 2019 (left) and 18 March 2019 (right). The size of the saturated hot thermal area (as indicated as solid white) for the 18 March 2019 image is several times that of the 17 March 2019 data. This is consistent with the fact that only 1 tank was burning on the 17th but six tanks appear to be burning during this mission.

Figure 4: 3 band IR images, Comparison of 17 and 18 March Data. 17 March 2019 is on the left, 18 March 2019 is on the right.

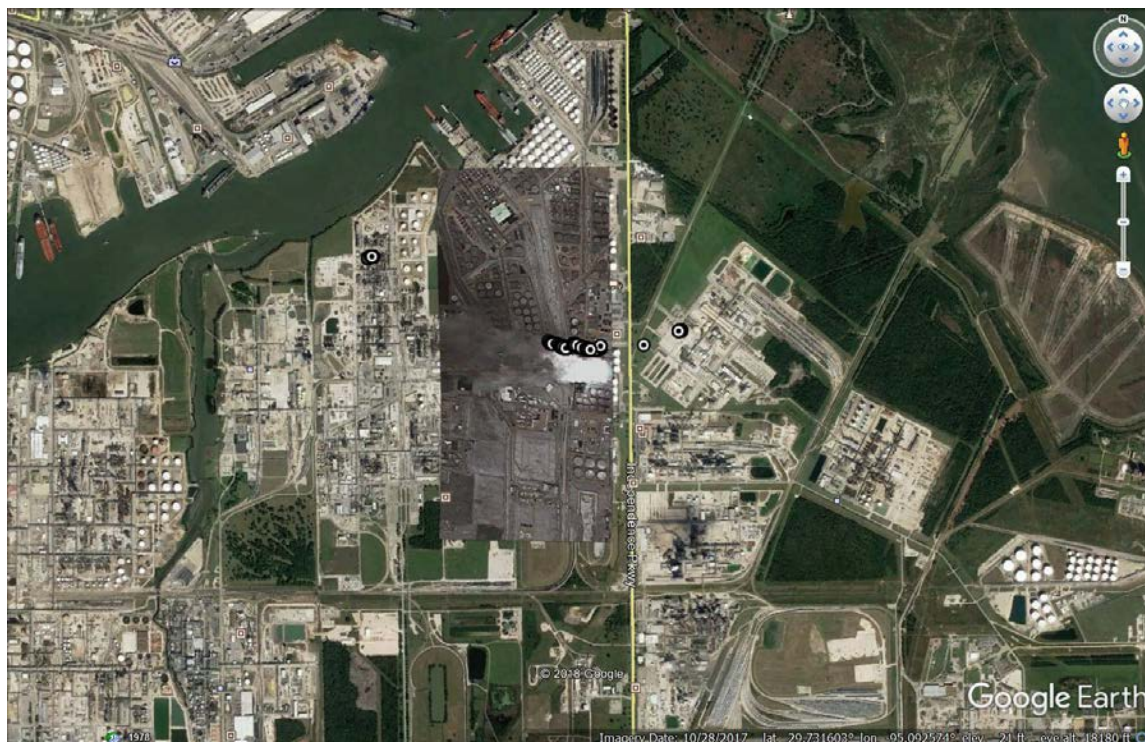
Spectral examination of the fire showed more detections than on the afternoon/evening of 17 March 2019. Figure 5 shows the where individual compounds were detected in relationship to the fire. Most of the compounds detected were made on the northern side of the fire. Compound detections east of the fire are most likely native compounds present in the urban air.

Figure 5: Chemical detections as denoted by dots on the image.

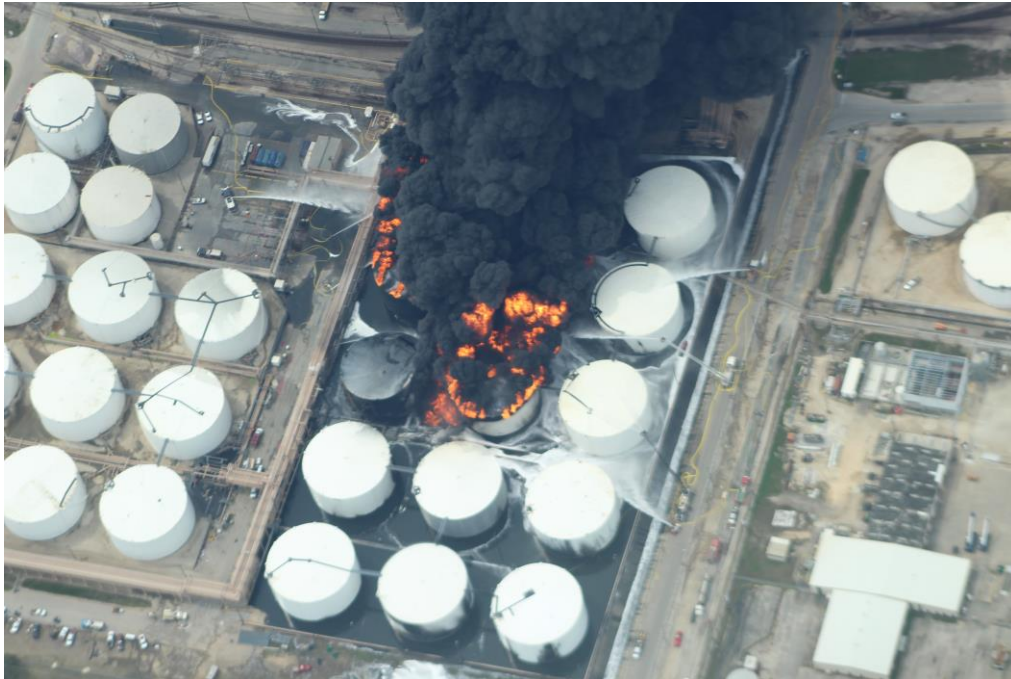
A full set of high resolution aerial digital photography were collected as part of the flight. Figure 6 shows a representative image collected as part of each pass. As discussed in the IRLS Figure 7 shows a representative oblique collected from the copilot station. This image clearly shows the presence of fire in the center tank with additional fire surrounding the tank. The fire is generating a large amount of smoke which is rising nearly vertical. The low light conditions of the image are actually a result of the plume shading the area as the aircraft passed over the site.

Figure 7: Oblique Image of the International Terminal Corporation Fire, Flt 2
